**Flood Control Project Maintenance
Levee Inspections**

Maintenance Issue Types Only, Levee Inspection Report By Mile - Fall 2016

Reclamation District No. 2095 Paradise Cut

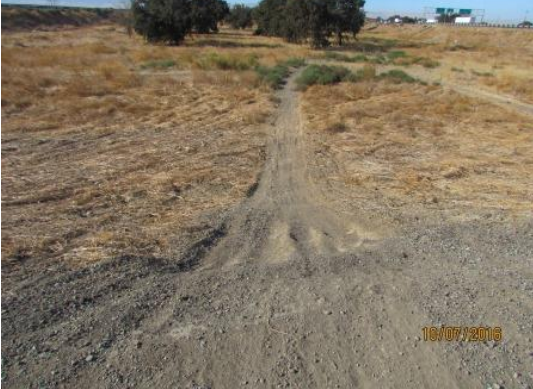
Photo 1 of 2 : FA_2016_RD2095_322_12_20161011_00025.jpg

Recent view of the vehicle tracks on the landside levee slope.

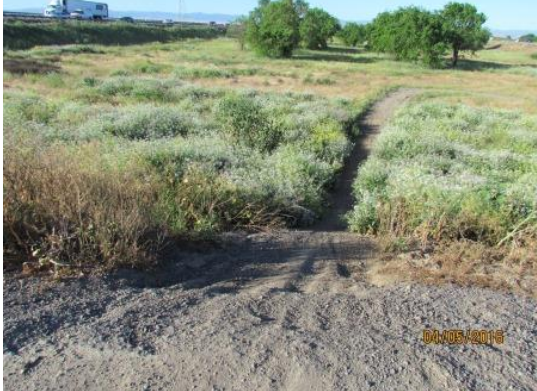
Photo 2 of 2 : FA_2016_RD2095_322_12_20160914_000007.jpg

View of the vehicle tracks on the landside levee slope.

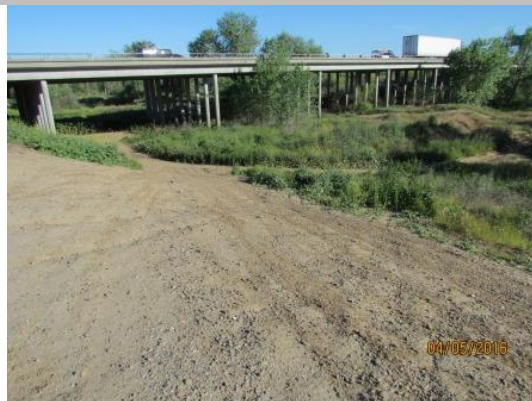
Photo 1 of 1 : FA_2016_RD2095_322_10_20160914_00005.jpg

LM Start	0.15	Rating **	M	Issue No.	10
LM End	0.15	Issue Type +	Ma	Location *	WS
Category	Earthen Levee			GPS Latitude/Longitude	
				Start	End
Item	Slope Stability			37.769997°	37.769997°
				-121.325055°	-121.325055°
DWR ID	DWR_RD2095_01_f_2015_10				
Comment Code					
S3 : Repair the levee slope damaged by vehicle traffic and prevent access where possible.					
Inspector Comment					
LMA is actively controlling access.

View of the vehicle tracks on the waterside levee slope.

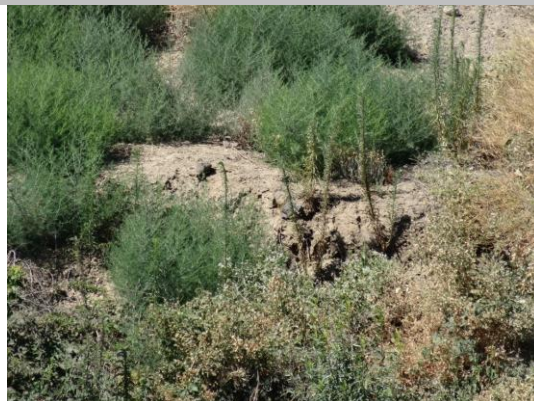
Photo 3 of 3 : SJR2016_RD2095U01RM6.74_3.jpg

07/20/2016: No significant change observed.
08/04/2015: No significant change observed.
08/26/2014: No significant change observed.
08/28/2013: No significant change observed.
07/18/2012: No significant change observed.
09/02/2011: No significant change observed.
09/22/2010: No significant change observed. There is now considerable vegetation at the water line and along the lower berm slope. However, the erosion on the lower berm slope is still present and has not been corrected.
08/06/2010: Recommended for local maintenance issue, per CLRO.
07/29/2009: No major change since last visit; noticeable vegetation growth; erosion is on berm, but if left untreated, it will eventually erode into levee prism; site is recommended for annual assessment and monitoring of the site, per CLRO CES 2008 Report; Site # is the same as RM6.80, LM0.73; previously rated "U".
07/22/2008: Downstream of WPRR near siphon pipe & pump; sandy levee; visited by Jeff Van Gilder and LRO in 2008 for repair assessment; scouring downstream of RR crossing, possibly caused by eddy effects.

Close view of the erosion downstream of the RR ridge.

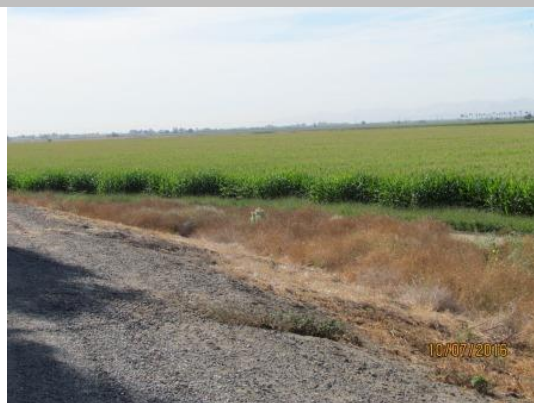
Photo 1 of 2 : FA_2016_RD2095_322_9_20161011_00026.jpg

LM Start	0.90	Rating **	M	Issue No.	9
LM End	1.44	Issue Type +	Ma	Location *	LS
Category	Earthen Levee			GPS Latitude/Longitude	
				Start	End
Item	Vegetation			37.761128 °	37.759201 °
				-121.317645 °	-121.308517 °
DWR ID	DWR_RD2095_01_f_2016_9				
Comment Code					
V1 : Control annual grass and weeds on the levee slopes and easements.					
Inspector Comment

View of the vegetation on the landside levee slope and toe.

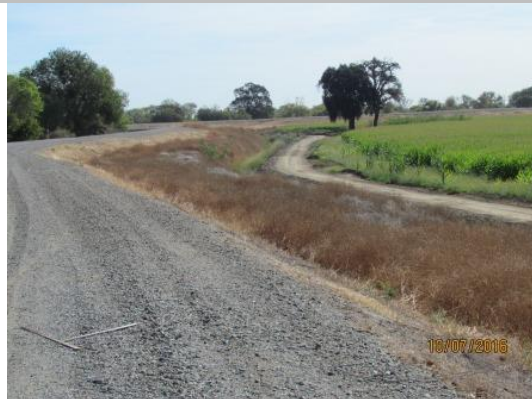
Photo 2 of 2 : FA_2016_RD2095_322_9_20161011_00027.jpg

LM Start	0.90	Rating **	M	Issue No.	9 (cont)	
LM End	1.44	Issue Type +	Ma	Location *	LS	
Category	Earthen Levee			GPS Latitude/Longitude		
				Start		End
Item	Vegetation			37.761128°		37.759201°
				-121.317645°		-121.308517°
DWR ID	DWR_RD2095_01_f_2016_9					
Comment Code						
V1 : Control annual grass and weeds on the levee slopes and easements.						
Inspector Comment

Another view of the vegetation on the landside levee slope and toe, facing the San Joaquin River.

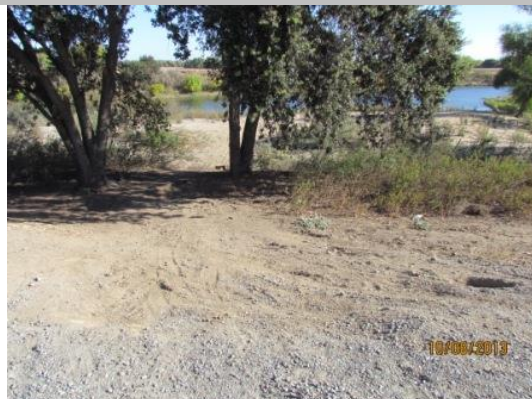
Photo 1 of 1 : FA_2016_RD2095_323_9_20160914_00007.jpg

LM Start	0.03	Rating **	A/W	Issue No.	9
LM End	0.03	Issue Type +	Ma	Location *	WS
Category	Earthen Levee			GPS Latitude/Longitude	
				Start	End
Item	Slope Stability			37.758986°	37.758986°
				-121.307854°	-121.307854°
DWR ID	DWR_RD2095_02_s_2013_9				
Comment Code					
S3 : Repair the levee slope damaged by vehicle traffic and prevent access where possible.					
Inspector Comment

View of the vehicle tire ruts on waterside levee slope.

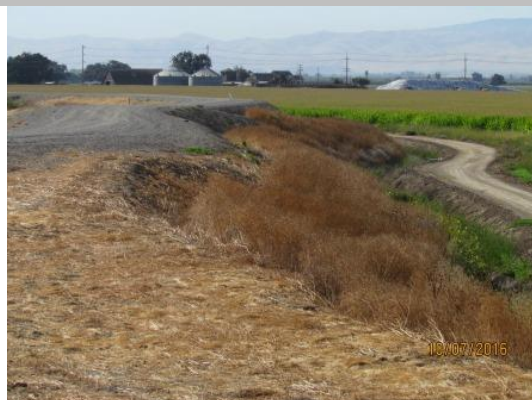
Photo 1 of 1 : FA_2016_RD2095_323_15_20161011_00027.jpg

LM Start	0.30	Rating **	M	Issue No.	15
LM End	0.37	Issue Type +	Ma	Location *	LS
Category	Earthen Levee			GPS Latitude/Longitude	
				Start	End
Item	Vegetation			37.755803 °	37.754829 °
				-121.305667 °	-121.305688 °
DWR ID	DWR_RD2095_02_f_2016_15				
Comment Code					
V1 : Control annual grass and weeds on the levee slopes and easements.					
Inspector Comment

View of the vegetation on the landside levee slope.

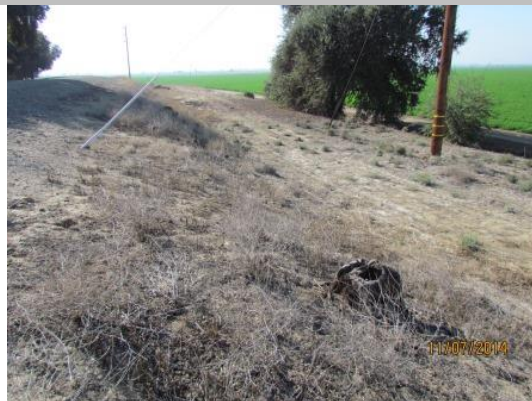
Photo 1 of 1 : FA_2016_RD2095_323_3_20160914_00005.jpg

LM Start	1.09	Rating **	N	Issue No.	3
LM End	1.09	Issue Type +	Ma	Location *	LS
Category	Earthen Levee			GPS Latitude/Longitude	
				Start	End
Item	Trim / Thin Trees			37.748184 °	37.748184 °
				-121.298995 °	-121.298995 °
DWR ID	DWR_RD2095_02_s_2012_3				
Comment Code					
T5 : Tree stumps.					
Inspector Comment					
4 stumps

View of the tree stumps on the landside levee slope..

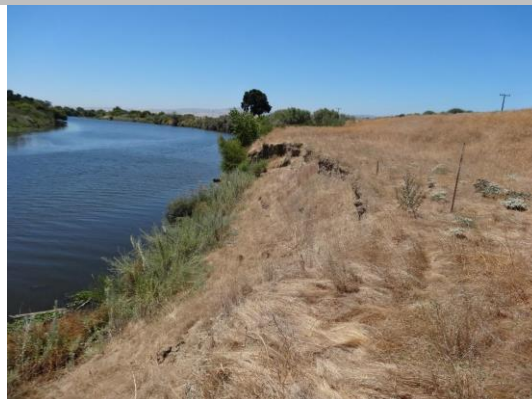
Photo 1 of 3 : SJR2016_RD2095U02RM60.62_1.jpg

07/20/2016: The erosion extended toward the levee toe. The berm width was reduced by approximately five (5) feet.
 08/04/2015: No significant change observed.
 07/02/2014: No significant change observed.
 08/28/2013: No significant change observed.
 09/13/2012: The site has been visited by land survey. The vegetation on the site shows the erosion has not developed significantly from the last survey.
 The site was not visited by boat survey due to the limitation of navigable waterway.
 08/23/2011: No significant change observed.
 9/22/2010: No significant change observed. There is moderate vegetation growth on the berm. Despite the erosion occurring on the berm, corrective action should be taken before the issue becomes severe.
 9/29/2009: Site is immediately downstream of a section of existing rip rap; there is a 20-foot berm remaining; berm will continue to erode unless erosion is mitigated; Site# is the same as RM62.6, LM1.87; recommended for annual assessment, per CES Evaluation 2008 Report 2006: Visited 10/20/06 [2016 Site ID:RD2095U02RM60.62]

Looking at the erosion from downstream of the site.

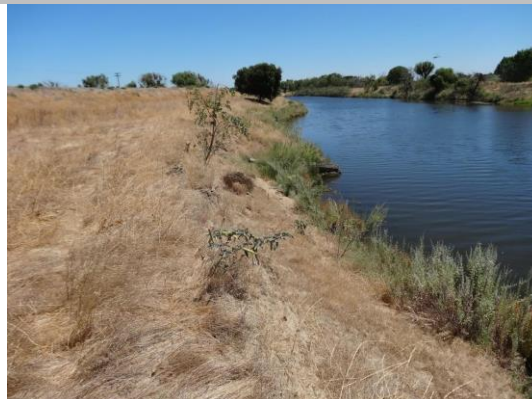
Photo 2 of 3 : SJR2016_RD2095U02RM60.62_2.jpg

Looking at the erosion from upstream of the site

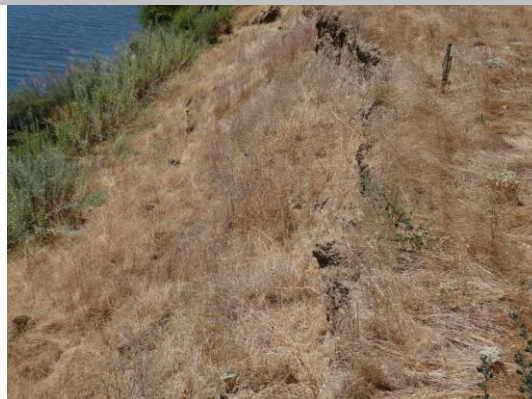
Photo 3 of 3 : SJR2016_RD2095U02RM60.62_3.jpg

07/20/2016: The erosion extended toward the levee toe. The berm width was reduced by approximately five (5) feet.
 08/04/2015: No significant change observed.
 07/02/2014: No significant change observed.
 08/28/2013: No significant change observed.
 09/13/2012: The site has been visited by land survey. The vegetation on the site shows the erosion has not developed significantly from the last survey.
 The site was not visited by boat survey due to the limitation of navigable waterway.
 08/23/2011: No significant change observed.
 9/22/2010: No significant change observed. There is moderate vegetation growth on the berm. Despite the erosion occurring on the berm, corrective action should be taken before the issue becomes severe.
 9/29/2009: Site is immediately downstream of a section of existing rip rap; there is a 20-foot berm remaining; berm will continue to erode unless erosion is mitigated; Site# is the same as RM62.6, LM1.87; recommended for annual assessment, per CES Evaluation 2008 Report 2006: Visited 10/20/06 [2016 Site ID:RD2095U02RM60.62]

Close view of the site.

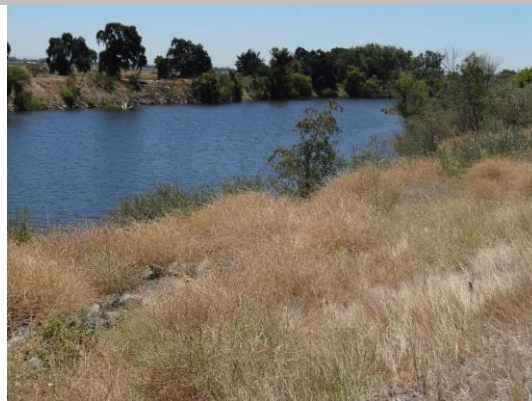
Photo 2 of 2 : SJR2016_RD2095U02RM60.69_2.jpg

07/20/2016: No significant change observed. Dense vegetation blocks the visual inspection at the site.
 08/04/2015: No significant change observed.
 7/02/2014: No significant change observed.
 08/28/2013: No significant change observed. Dense vegetation blocks the visual inspection at the site.
 09/13/2012: The site has been visited by land survey. The erosion is not visible from the levee slope because of dense vegetation at the site. Levee slope is protected by placed rocks. The site was not visited by boat survey due to the limitation of navigable waterway.
 08/23/2011: Dense vegetation makes it difficult to view the possible erosion. No new development was observed on site.
 09/23/2010: At the time of the inspection, the erosion site was difficult to view from the levee. The erosion is located on the bank toe, below the existing rip rap. There were no signs of repair on site, nor has the site been reported to be repaired by the district. Images taken from last year indicate that existing rip rap at the bank toe has sloughed exposing the underlying soils. Weakening of the toe could lead to future bank instability.

The erosion is not visible from the levee top. The levee slope is protected by riprap rocks.

08/05/2010: Recommended for annual assessment and monitoring during flood events, per CLRO.
 09/29/2009: No major change observed since last visit; sloughing of the rip rap above toe; erosion begins immediately downstream of existing rip rap revetment; roughly 15-foot berm remains; however, it will continue to erode and eventually intrude into the levee profile if left untreated.
 10/20/2006: Just upstream of where berm starts to widen. [2016 Site ID:RD2095U02RM60.69]

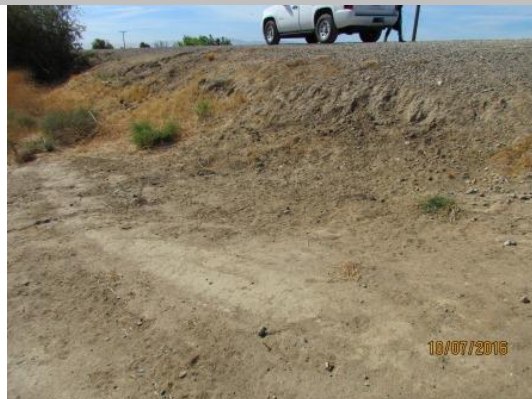
Photo 1 of 2 : FA_2016_RD2095_323_19_20161011_00023.jpg

LM Start	2.09	Rating **	M	Issue No.	19
LM End	2.09	Issue Type +	Ma	Location *	WS
Category	Earthen Levee			GPS Latitude/Longitude	
				Start	End
Item	Slope Stability			37.735276 °	37.735276 °
				-121.297777 °	-121.297777 °
DWR ID	DWR_RD2095_02_f_2016_19				
Comment Code					
S1 : Repair slope instability.					
Inspector Comment

View of the erosion on the waterside levee slope.

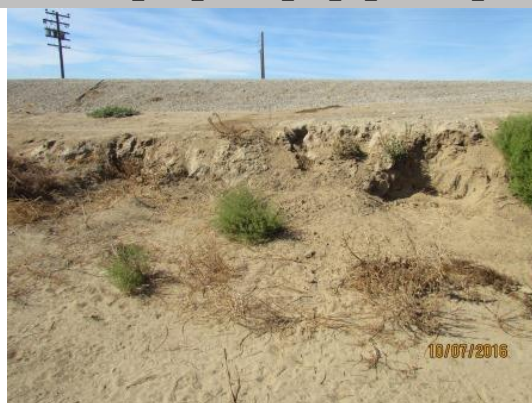
Photo 2 of 2 : FA_2016_RD2095_323_19_20161011_00024.jpg

View of the erosion caused by excavation on the waterside levee slope.

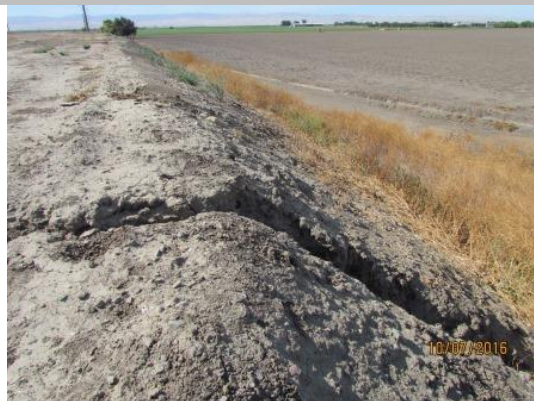
Photo 1 of 2 : FA_2016_RD2095_323_21_20161011_00025.jpg

LM Start	2.85	Rating **	M	Issue No.	21
LM End	2.85	Issue Type +	Ma	Location *	LS
Category	Earthen Levee			GPS Latitude/Longitude	
				Start	End
Item	Erosion / Bank Caving			37.724647 °	37.724647 °
				-121.299749 °	-121.299749 °
DWR ID	DWR_RD2095_02_f _ 2016_21				
Comment Code					
E2 : Schedule repair of erosion site prior to the next inspection.					
Inspector Comment

View of the landside levee slope erosion.

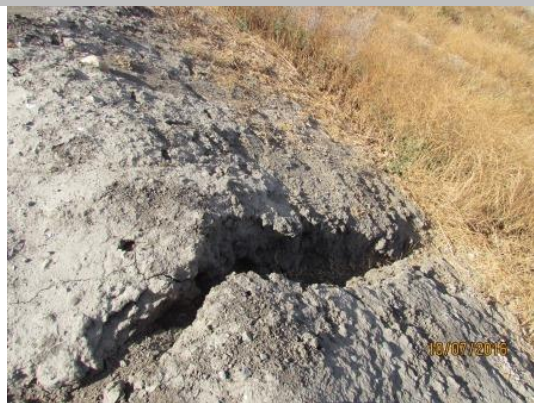
Photo 2 of 2 : FA_2016_RD2095_323_21_20161011_00026.jpg

Another view of the landside levee slope erosion.
